**Flood Control Project Maintenance
Levee Inspections**

Fall 2019 Levee Maintenance Deficiency Summary Report

Levee District No. 0001 (Glenn County)

Waterway			Bank	Unit Miles
Unit No. 01 Sacramento River			Right	12.23
	Spring (March - May)	Summer (June - August)	(September - November) Fall	Winter (December - February)
Unit Maintenance Rating (Fall Only)			A	
Date of Inspection	4/26/2019 - 4/26/2019		9/17/2019 - 9/17/2019	
DWR Inspector	Makar Sokol		Makar Sokol	
Accompanied By	Nick Henning		Nick Henning	
	Nick Perez

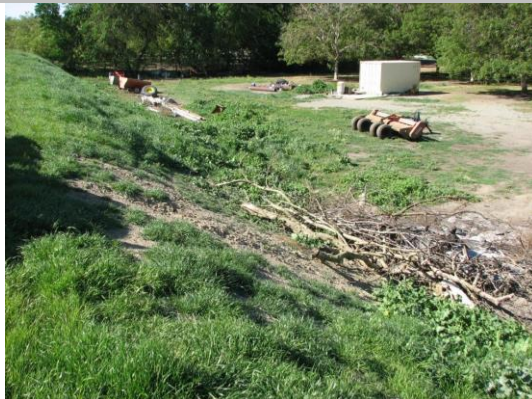
Photo 1 of 1 : FA_2019_LD0001G_432_73_20190822_00023.jpg

LM Start	0.02	Rating **	M	Issue No.	73
LM End	0.04	Issue Type +	En	Location *	LS
Category	Earthen Levee			GPS Latitude/Longitude	
				Start	End
Item	Encroachments			39.477372 °	39.477833 °
				-122.017602 °	-122.017484 °
DWR ID	DWR_LD0001G_01_s_2016_73				
Comment Code					
EQ : Equipment					
Inspector Comment					
Remove agricultural equipment from the landside toe.

View of the prunings pile and ag equipment at the landside toe.

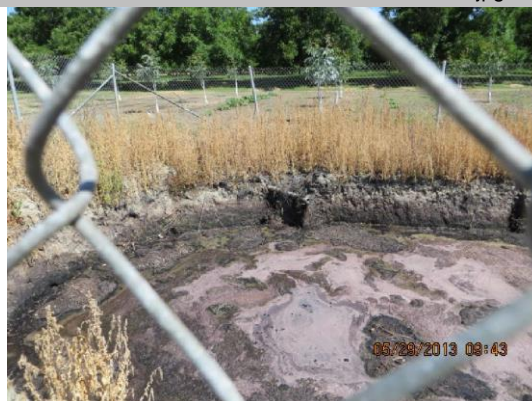
Photo 1 of 3 : UCIP_FA_2019_14324_23564.jpg

LM Start	0.77	Rating **	M	Issue No.	396	
LM End	0.77	Issue Type +	En	Location *		
Category	Supplemental			GPS Latitude/Longitude		
				Start	End	
Item	DRAFT DWR UCIP Field Study			39.487806 °	39.487806 °	
				-122.019414 °	-122.019414 °	
DWR ID	22893					
Comment Code						
Inspector Comment						
DS_ID:22893 FS_ID:14324 EP_NO: 11782 Repair Type: Non-Urgent Crossing Status: Found UCIP Comments: 5/29/2013 - Siphon breaker missing from WS shoulder (W. Wylie - DWR UCIP) FIELD_STRUCT_DESC: 3-inch galvanized steel water pipe through the levee, 2 feet below the crown. There is a hose bib style siphon breaker on the waterside (WS) shoulder. A pipe runs from the concrete sump next to the barn on the landside (LS) to a cesspool off of the WS toe. (Permit No. 11782, 1976 - Carriere Brothers). [Additional Reference(s): DWR Levee Log, 1992]. FS Date: 5/29/2013

3-inch pipe at cesspool off WS toe.

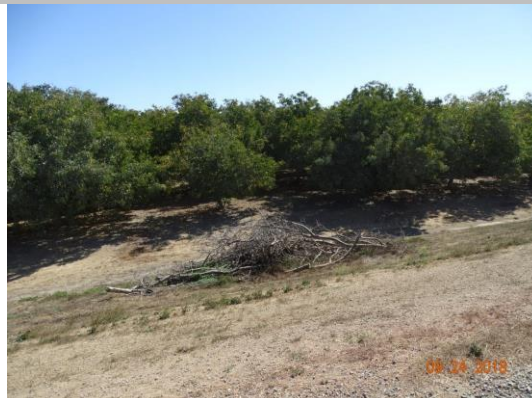
Photo 1 of 1 : FA_2019_LD0001G_432_61_20190822_00017.jpg

LM Start	0.92	Rating **	M	Issue No.	61
LM End	0.92	Issue Type +	En	Location *	WS
Category	Earthen Levee			GPS Latitude/Longitude	
				Start	End
Item	Encroachments			39.489718 °	39.489718 °
				-122.020650 °	-122.020650 °
DWR ID	DWR_LD0001G_01_f_2018_61				
Comment Code					
PR : Prunings					
Inspector Comment					
Prunings should be removed from the waterside toe.

View of the prunings along the waterside toe.

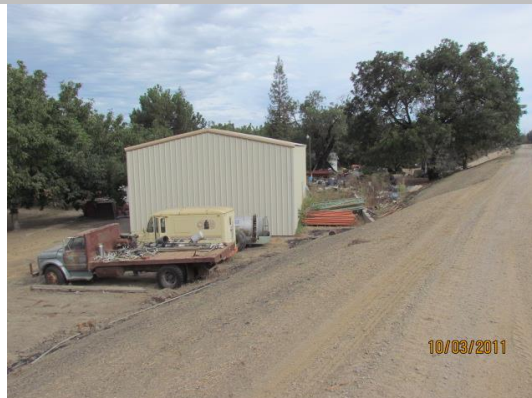
Photo 1 of 1 : FA_2019_LD0001G_432_4_20190822_00001.jpg

LM Start	1.11	Rating **	M	Issue No.	4							
LM End	1.11	Issue Type +	En	Location *	LS							
Category	Earthen Levee		GPS Latitude/Longitude									
			Start	End								
Item	Encroachments		39.491887°	39.494572°								
			-122.020238°	-122.017840°								
DWR ID	DWR_LD0001G_01_s_2012_4											
Comment Code												
BU : Building												
Inspector Comment

View of unpermitted building LS toe.

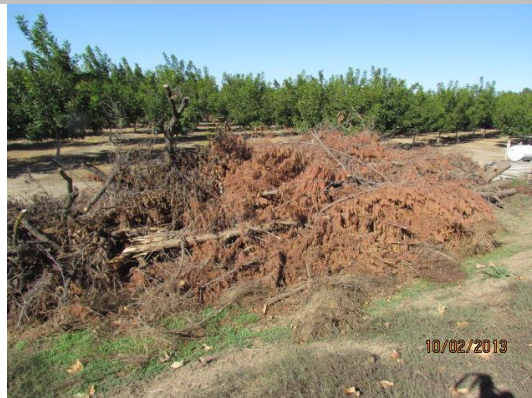
Photo 1 of 1 : FA_2019_LD0001G_432_56_20190822_00015.jpg

LM Start	3.63	Rating **	M	Issue No.	56
LM End	3.63	Issue Type +	En	Location *	LS
Category	Earthen Levee			GPS Latitude/Longitude	
				Start	End
Item	Encroachments			39.520623 °	39.520623 °
				-122.010457 °	-122.010457 °
DWR ID	DWR_LD0001G_01_f_2013_56				
Comment Code					
PR : Prunings					
Inspector Comment					
Prunings should be removed from the landside slope and toe.

View of the prunings and limbs along the slope of the levee.

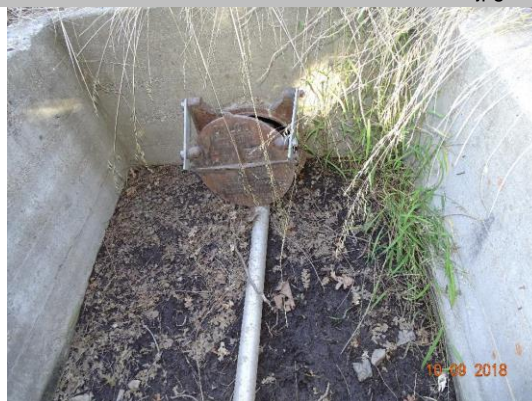
Photo 2 of 3 : UCIP_FA_2019_53006_78124.jpg

3-inch pipe obstructs flap gate from complete closing.

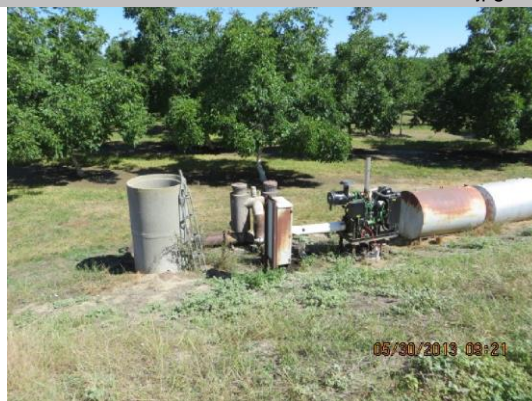
Photo 1 of 3 : UCIP_FA_2019_51284_23594.jpg

Pump, standpipe, and gate valve on LS toe.

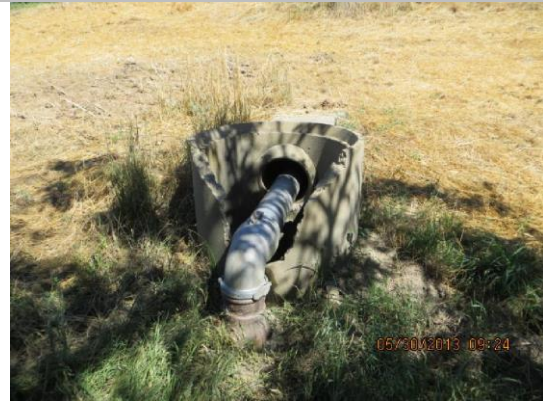
Photo 3 of 3 : UCIP_FA_2019_51284_23592.jpg

Comment Code					
Inspector Comment					
DS_ID:22906 FS_ID:51284 EP_NO: 1229 Repair Type: Non-Urgent Crossing Status: Found UCIP Comments: 12/21/2016 same as last inspection. Crossing has been modified from original permit. Need to contact owner to determine permit number issued for modification and to determine current status of crossing. Crossing has been downgraded from Urgent to Non-Urgent due to no damage observed on levee slopes or crown. (O. Magana - DWR UCIP)05/30/2013 Gate valve broken off in concrete standpipe on WS shoulder. 8-inch aluminum pipe sleeved through pipe prevents closure of 18-inch pipe. All concrete standpipes have been modified or broken. (W. Wylie - DWR UCIP) FIELD_STRUCT_DESC: 16-inch concrete (not 18-inch asphalt dipped steel as referenced in permit or USACE O&M manual) irrigation pipe through the levee, 8.6 feet below the crown. Gate valve in concrete well located on the waterside (WS) slope. Pump, service pole, engine, and fuel tank 48-inch, and standpipe are located on the toe of the landside (LS) slope (Permit No. 1229, 1947 - R. T. Miller). [Additional Reference(s): DWR Levee Log, 1992. USACE Sacramento O&M Manual Unit 140, May 1960, (HLM 4.33)]. FS Date: 12/21/2016

8-inch pipe sleeved through 16-inch pipe at LS toe.

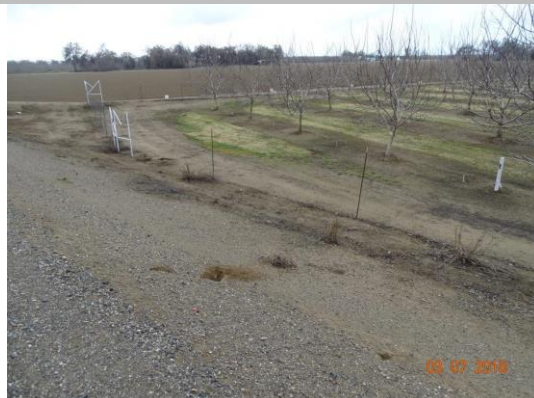
Photo 1 of 1 : FA_2019_LD0001G_432_70_20190822_00021.jpg

LM Start	5.83	Rating **	M	Issue No.	70
LM End	5.83	Issue Type +	Ma	Location *	LS
Category	Earthen Levee			GPS Latitude/Longitude	
				Start	End
Item	Animal Control			39.544894 °	39.544894 °
				-122.001077 °	-122.001077 °
DWR ID	DWR_LD0001G_01_s_2018_70				
Comment Code					
A3 : No rodents visible, but rodent burrows visible; need to backfill and compact or grout burrows.					
Inspector Comment

View of the rodent holes along the landside slope.

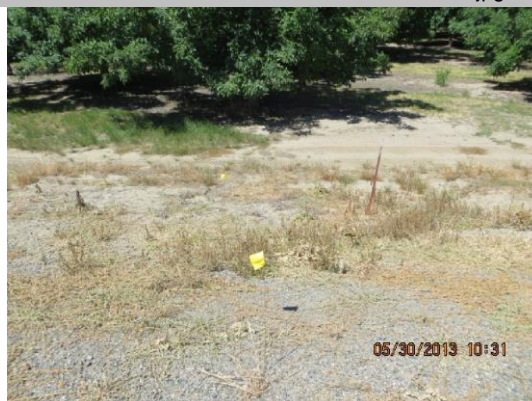
Photo 1 of 2 : UCIP_FA_2019_14352_23609.jpg

LM Start	6.18	Rating **	M	Issue No.	406	
LM End	6.18	Issue Type +	En	Location *		
Category	Supplemental			GPS Latitude/Longitude		
				Start	End	
Item	DRAFT DWR UCIP Field Study			39.549911 °	39.549911 °	
				-122.002102 °	-122.002102 °	
DWR ID	22911					
Comment Code						
Inspector Comment						
DS_ID:22911						
FS_ID:14352						
EP_NO: 5118						
Repair Type: Non-Urgent						
Crossing Status: Indicator Found						
UCIP Comments: New gasoline markers should be installed as existing signage has been sun faded						
FIELD_STRUCT_DESC: 1 of 2: 12.75-inch high pressure gas pipeline of an unknown material through the levee, 3 feet below the crown.						
(Permit No. 5118, 1965 - PG&E). [Additional Reference(s): DWR Levee Log, 1992].						
FS Date: 5/30/2013

Gasline flags on LS slope.

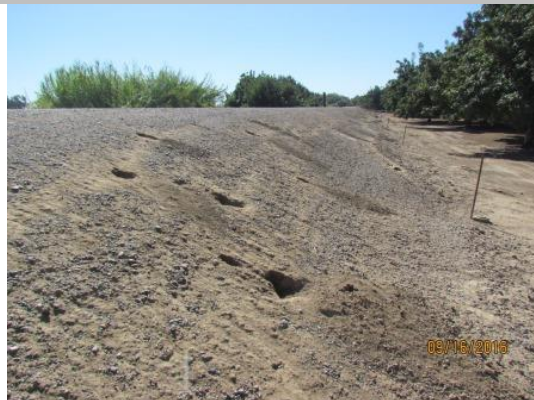
Photo 1 of 1 : FA_2019_LD0001G_432_76_20190822_00024.jpg

LM Start	6.24	Rating **	M	Issue No.	76
LM End	6.24	Issue Type +	Ma	Location *	LS
Category	Earthen Levee			GPS Latitude/Longitude	
				Start	End
Item	Animal Control			39.550725 °	39.550725 °
				-122.002370 °	-122.002370 °
DWR ID	DWR_LD0001G_01_f_2016_76				
Comment Code					
A3 : No rodents visible, but rodent burrows visible; need to backfill and compact or grout burrows.					
Inspector Comment

View of the rodent holes along the landside slope.

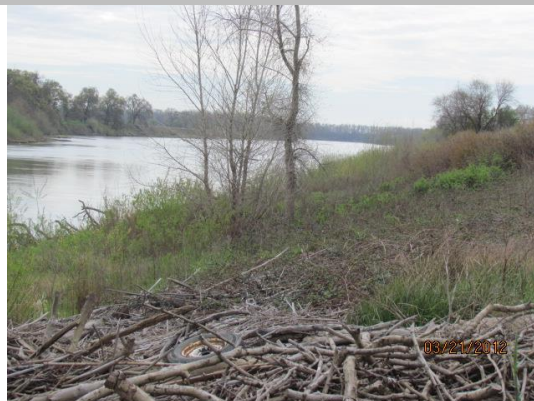
Photo 1 of 1 : FA_2019_LD0001G_432_10_20190822_00004.jpg

LM Start	6.38	Rating **	A/W	Issue No.	10
LM End	6.64	Issue Type +	Ob	Location *	WS
Category	Earthen Levee			GPS Latitude/Longitude	
				Start	End
Item	Vegetation			39.552691 °	39.556459 °
				-122.003063 °	-122.003831 °
DWR ID	DWR_LD0001G_01_s_2012_10				
Comment Code					
V8 : Environmental Requirements.					
Inspector Comment

View of the Army Corps of Engineers mitigation site.

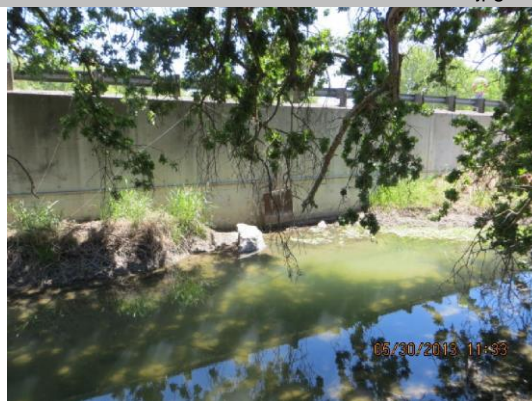
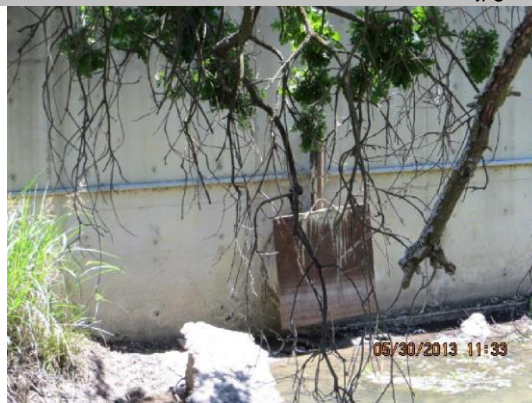
Pipe with steel plate welded over end on LS of levee crown.

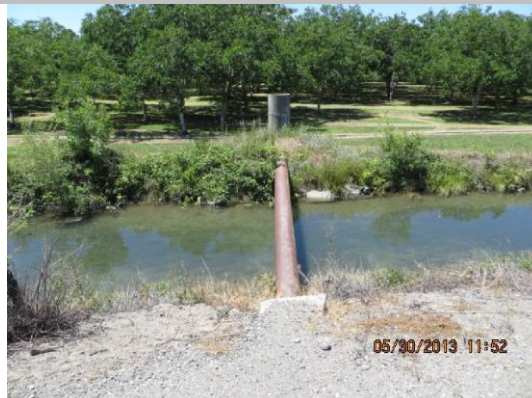
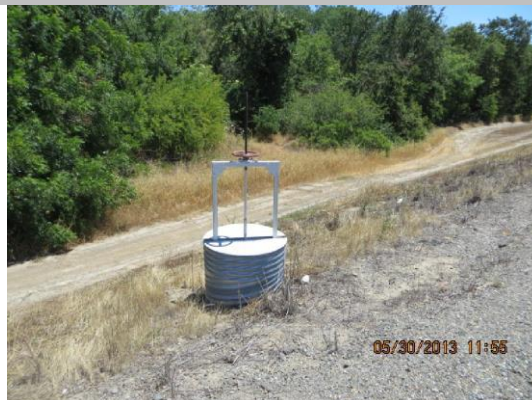
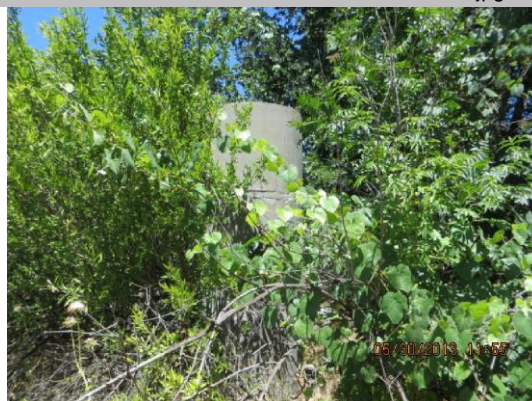
Pipe on LS toe with concrete standpipe visible.

Slide gate in 36-inch CMP standpipe on WS slope

Comment Code						
Inspector Comment						
DS_ID:22917 FS_ID:14384 EP_NO: 9702 Repair Type: Non-Urgent Crossing Status: Found UCIP Comments: Abandoned and should be done so properly. FIELD_STRUCT_DESC: 20-inch concrete encased steel irrigation pipe through the levee, 7.2 feet below the crown. Slant pump located on the waterside (WS) bank. Slide gate in 36-inch concrete standpipe on the WS berm. (24-inch pipe authorized under Automatic Board Order (ABO) issued as Permit No. 9702, 1974 - Joe and Mary Bertapelle). [Additional Reference(s): DWR Levee Log, 1992, 24-inch corrugated metal pipe listed. USACE Sacramento O&M Manual 140, May 1960, (HLM 7.01), 24-inch pipe listed]. FS Date: 5/30/2013

Concrete standpipe off WS toe.

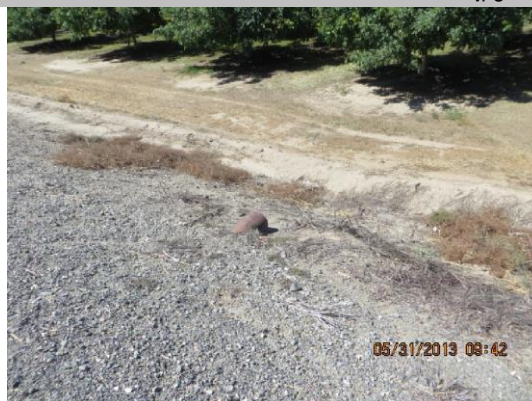
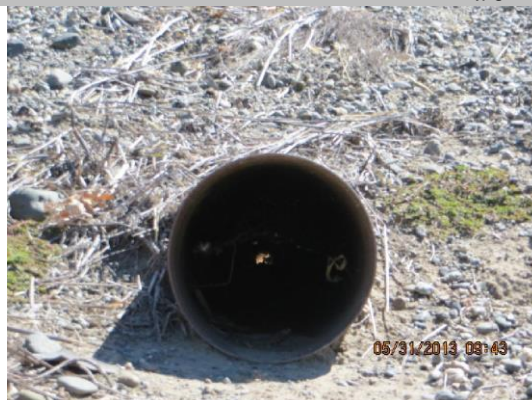
Pipe on LS slope.

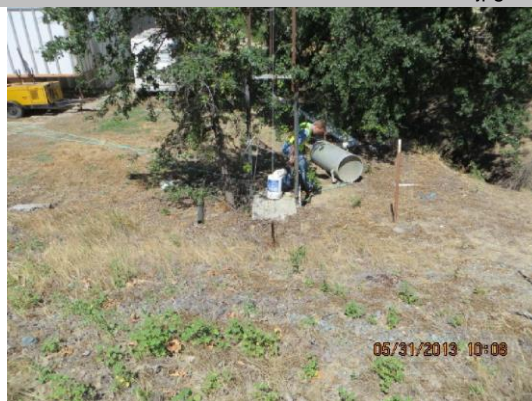
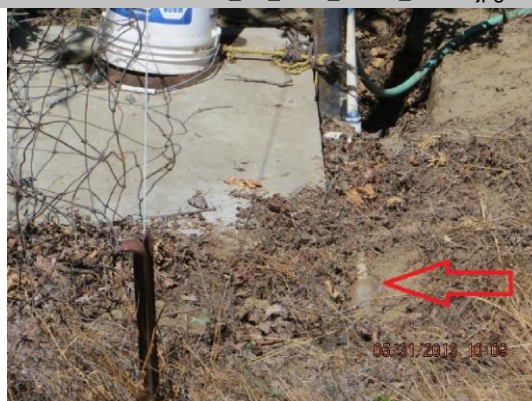
Pipe visible next to well with bucket over standpipe.

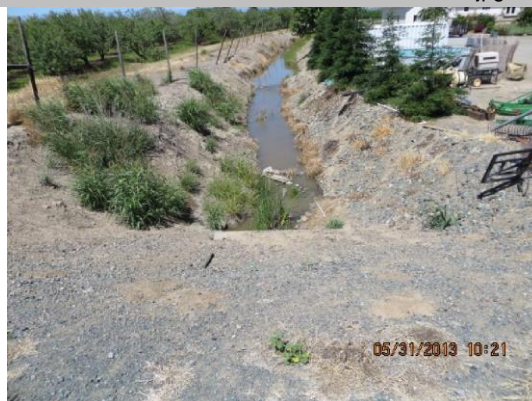
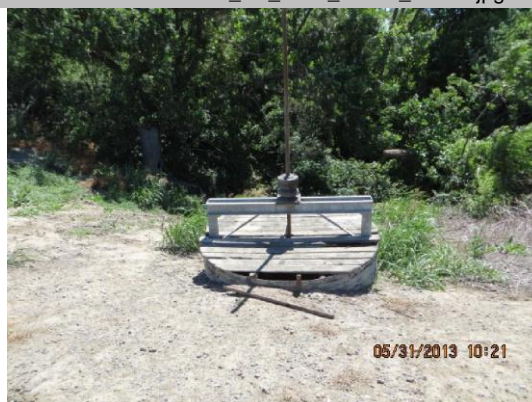
Pipe and headwall at LS toe.

Slide gate in 8-foot diameter CMP riser on WS slope.

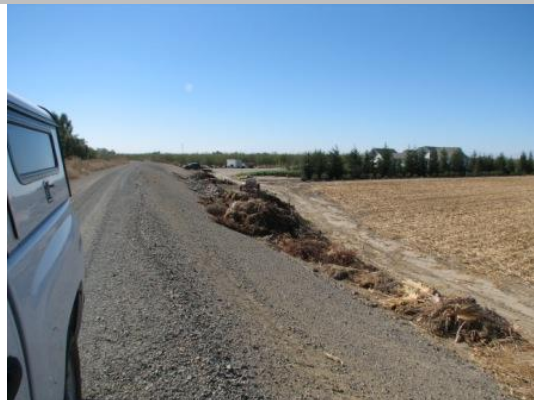
Photo 1 of 1 : FA_2019_LD0001G_432_11_20190822_00005.jpg

LM Start	9.54	Rating **	M	Issue No.	11
LM End	9.64	Issue Type +	En	Location *	LS
Category	Earthen Levee			GPS Latitude/Longitude	
				Start	End
Item	Encroachments			39.596705 °	39.598066 °
				-122.002247 °	-122.001704 °
DWR ID	DWR_LD0001G_01_s_2012_11				
Comment Code					
DE : Debris					
Inspector Comment					
Landscaping materials should be removed from the landside slope and toe.

View of debris along the toe of the levee.

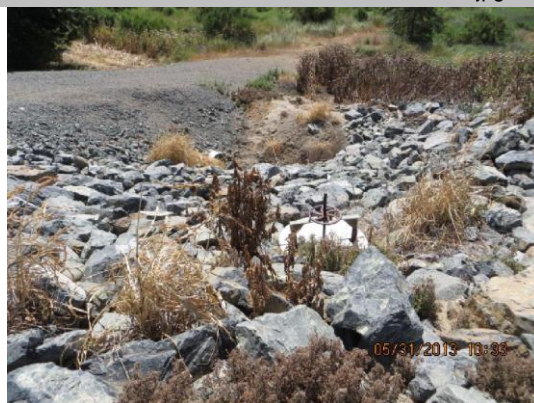
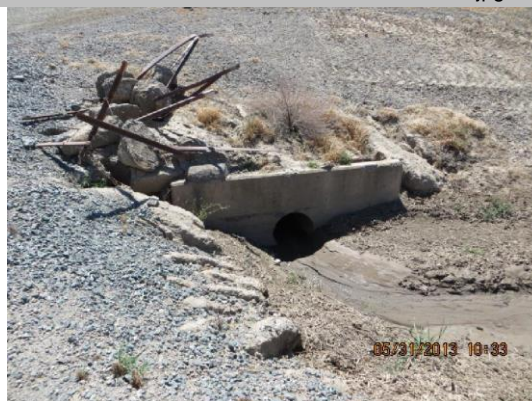
Comment Code						
Inspector Comment						
DS_ID:22921						
FS_ID:14390						
EP_NO: 9559						
Repair Type: No Action Needed						
Crossing Status: Found						
UCIP Comments:						
FIELD_STRUCT_DESC: 24-inch corrugated metal drainage pipe through the levee, 11 feet below the crown. Flap gate located on the waterside (WS) end. Slide gate in 36-inch corrugated metal riser unit on the WS slope. Concrete headwalls on both ends. Two corrugated metal cutoff walls. (24-inch pipe [HLM 10.05] authorized under Automatic Board Order (ABO) issued as Permit No. 9559, 1974 - David and Mary Giesbrecht). [Additional Reference(s): DWR Levee Log, 1992. USACE Sacramento O&M Manual 140, May 1960, (HLM 10.05)].						
FS Date: 5/31/2013

Slide gate in 36-inch CMP riser on WS slope.

Concrete headwall and pipe at LS toe.

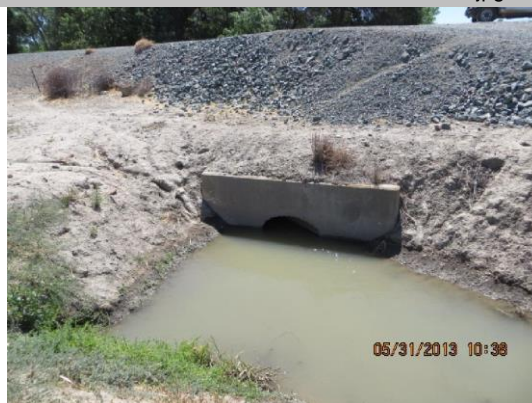
Photo 1 of 3 : UCIP_FA_2019_14559_23986.jpg

Comment Code						
Inspector Comment						
DS_ID:22922						
FS_ID:14559						
EP_NO: 9558						
Repair Type: No Action Needed						
Crossing Status: Found						
UCIP Comments:						
FIELD_STRUCT_DESC: 24-inch corrugated metal drainage pipe through the levee, 11 feet below the crown. Flap gate located on the waterside (WS) end. Slide gate in 36-inch corrugated metal pipe riser unit on the WS slope. Two corrugated metal cutoff walls. Concrete headwalls on both ends. (24-inch pipe [HLM 10.08] authorized under Automatic Board Order (ABO) issued as Permit No. 9558, 1974 - Duard Geis). [Additional Reference(s): DWR Levee Log, 1992. USACE Sacramento O&M Manual 140, May 1960, (HLM 10.08)].						
FS Date: 5/31/2013 8:43:01 AM

Pipe and headwall on LS toe.

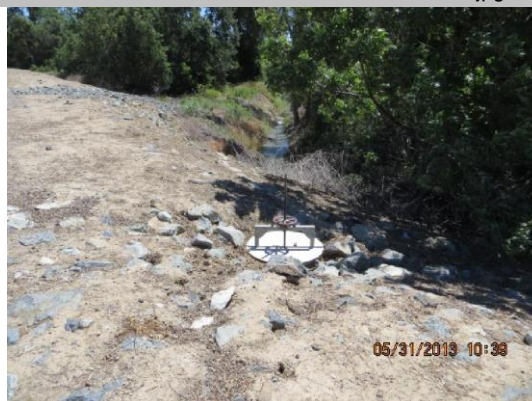
Photo 2 of 3 : UCIP_FA_2019_14559_23985.jpg

Slide gate in 36-inch CMP riser on WS slope.

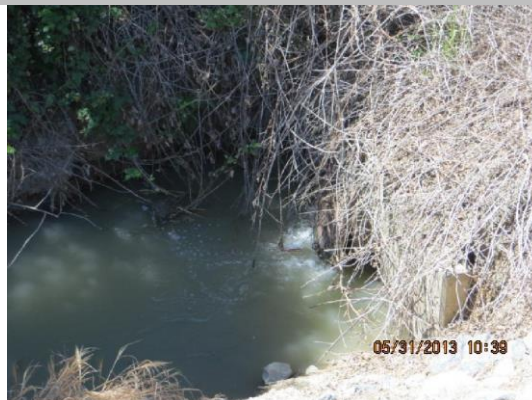
Photo 3 of 3 : UCIP_FA_2019_14559_23984.jpg

Pipe, flapgate, and headwall on WS toe.

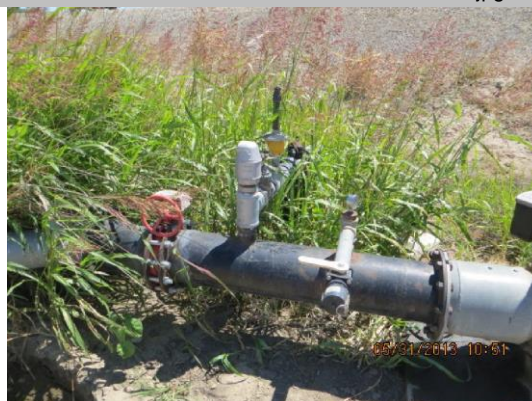
Photo 1 of 3 : UCIP_FA_2019_16205_27333.jpg

LM Start	10.20	Rating **	M	Issue No.	415	
LM End	10.20	Issue Type +	En	Location *		
Category	Supplemental			GPS Latitude/Longitude		
				Start	End	
Item	DRAFT DWR UCIP Field Study			39.604696 °	39.604696 °	
				-121.996265 °	-121.996265 °	
DWR ID	23148					
Comment Code						
Inspector Comment						
DS_ID:23148 FS_ID:16205 EP_NO: N/A Repair Type: Non-Urgent Crossing Status: Found UCIP Comments: Need to determine Permit No. for crossing. FIELD_STRUCT_DESC: 6-inch steel irrigation conduit through the levee, 8 inches below the crown. Pump, vent, filter, and siphon breaker on the landside (LS) toe. 4-inch polyvinyl chloride irrigation line sleeved through conduit for vegetation rehabilitation on the waterside (WS) slope. FS Date: 5/31/2013

Pump with siphon breaker, vent and filter on LS toe.

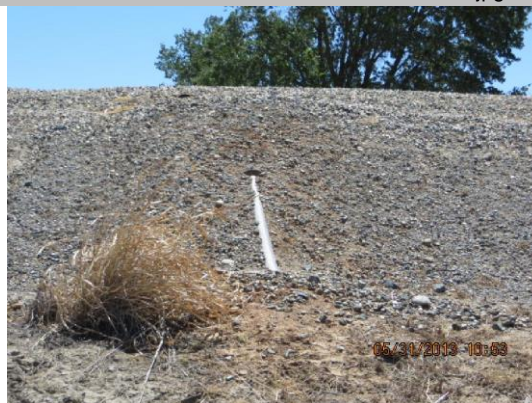
Photo 2 of 3 : UCIP_FA_2019_16205_27332.jpg

Pipe on LS slope.

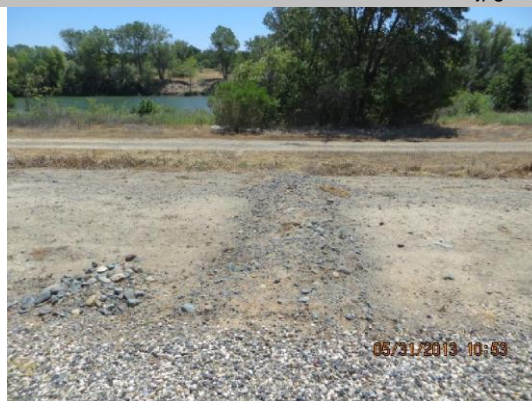
Photo 3 of 3 : UCIP_FA_2019_16205_27331.jpg

Cover over pipe on WS berm.

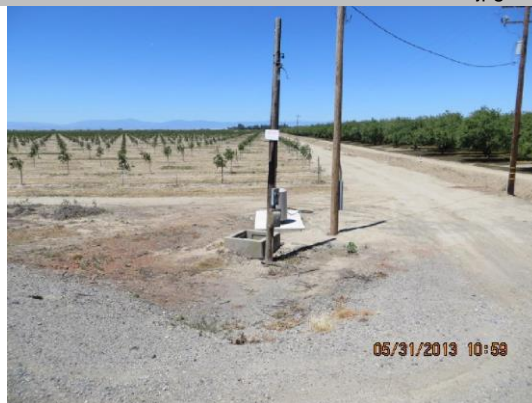
Photo 1 of 3 : UCIP_FA_2019_14561_23989.jpg

Comment Code						
Inspector Comment						
DS_ID:22923						
FS_ID:14561						
EP_NO: 9557						
Repair Type: Non-Urgent						
Crossing Status: Found						
UCIP Comments: This pipe appears abandoned and should be done so properly.						
FIELD_STRUCT_DESC: 1 of 2: 10-inch irrigation pipe of an unknown material through the levee, 3.7 feet below the crown. Pump on bank. Siphon breaker on the waterside (WS) berm. One corrugated metal cutoff wall. Concrete distribution box at the landside (LS) toe. (10-inch pipe authorized under Automatic Board Order (ABO) issued as Permit No. 9557, 1974 - Robert and Ruth Weis). [Additional Reference(s): DWR Levee Log, 1992. USACE Sacramento O&M Manual 140, May 1960, (HLM 10.56)].						
FS Date: 5/31/2013

Concrete distribution box at LS toe.

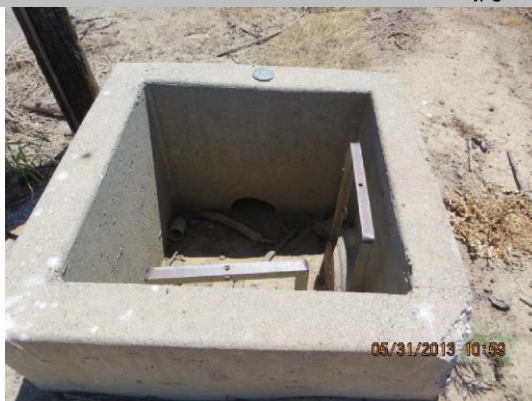
Photo 2 of 3 : UCIP_FA_2019_14561_23988.jpg

Concrete distribution box at LS toe with outlet from pipe through levee.

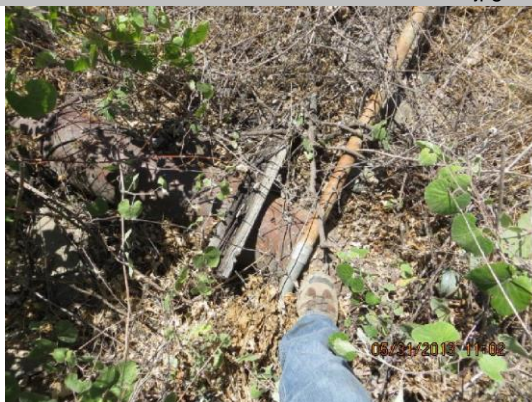
Photo 3 of 3 : UCIP_FA_2019_14561_23987.jpg

10-inch steel pipe and 1.5-inch electrical conduit on WS slope.

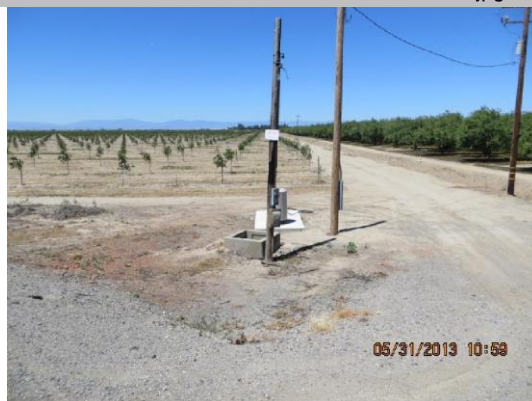
Photo 1 of 2 : UCIP_FA_2019_14562_23991.jpg

LM Start	10.41	Rating **	M	Issue No.	417
LM End	10.41	Issue Type +	En	Location *	
Category	Supplemental			GPS Latitude/Longitude	
				Start	End
Item	DRAFT DWR UCIP Field Study			39.607474 °	39.607474 °
				-121.994410 °	-121.994410 °
DWR ID	22938				
Comment Code					
Inspector Comment					
DS_ID:22938					
FS_ID:14562					
EP_NO: 9557					
Repair Type: Non-Urgent					
Crossing Status: Found					
UCIP Comments: Abandoned and should be done so properly.					
FIELD_STRUCT_DESC: 2 of 2: 1.5-inch galvanized iron electrical conduit through the levee, 3 feet below the crown. (Automatic Board Order (ABO) issued as Permit No. 9557, 1974 - Robert and Ruth Weis).					
[Additional Reference(s): DWR Levee Log, 1992. USACE Sacramento O&M Manual 140, May 1960, (HLM 10.56)].					
FS Date: 5/31/2013

Source at JP next to concrete distribution box at LS toe.

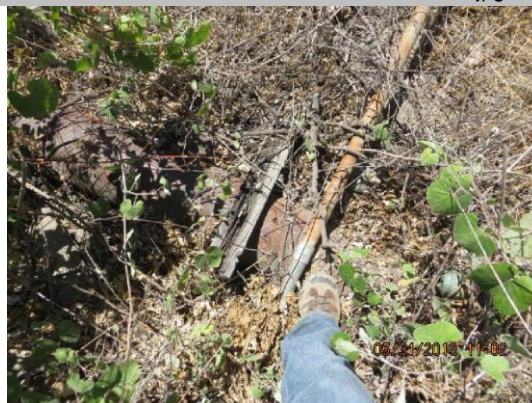
Photo 2 of 2 : UCIP_FA_2019_14562_23990.jpg

Pipe visible off WS toe.

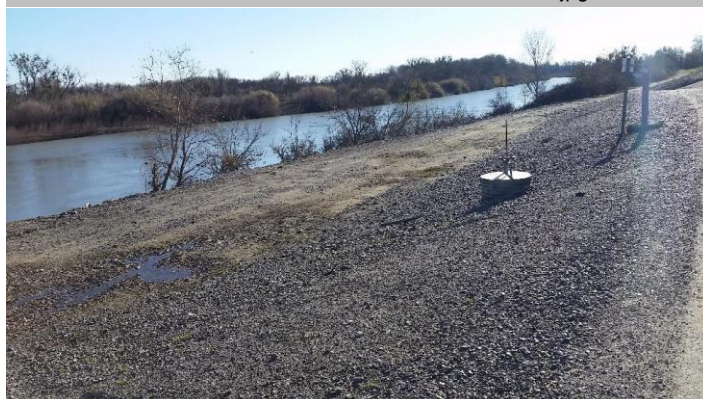
Photo 1 of 3 : UCIP_FA_2019_53340_76411.jpg

Comment Code						
Inspector Comment						
DS_ID:22924 FS_ID:53340 EP_NO: 9556 Repair Type: Urgent Crossing Status: Found UCIP Comments: 10/9/2018 Large rock at the bottom of CMP riser obstructs slide gate from completely closing. Pipe is rusted through at WS end. Recommend internal inspection to determine condition of pipe through levee, and to clean the inside of CMP riser for proper slide gate function. (O.Yakimov - DWR UCIP)12/21/2016 same as last inspection flap gate disabled in open position. Surface erosion observed on LS slope. Recommend repair on WS flap gate to be able to close flap gate. (O. Magana - DWR UCIP)05/31/2013 Flap gate dissabled in open position. Pipe rusted through at WS toe upstream of Flapgate. (W. Wylie - DWR UCIP) FIELD_STRUCT_DESC: 24-inch corrugated metal drainage pipe through levee, 15 feet below crown. Flap gate is located on the waterside (WS) end. Slide gate is inside a corrugated metal pipe (CMP) riser located on the WS slope. Two CM cutoff walls. Concrete headwall is located on LS and under outlet at the WS toe. (24-inch pipe [HLM 10.59] authorized under Automatic Board Order (ABO) issued as Permit No. 9556, 1974 - E. R & M. R. Cooper). [Additional Reference(s): DWR Levee Log, 1992. USACE Sacramento O&M Manual Unit 140, May 1960, (HLM 10.59)]. FS Date: 10/9/2018 4:05:00 PM

View of WS.

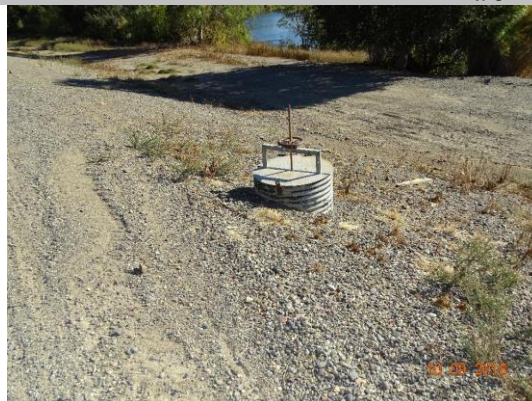
Photo 2 of 3 : UCIP_FA_2019_53340_78135.jpg

Water-Side

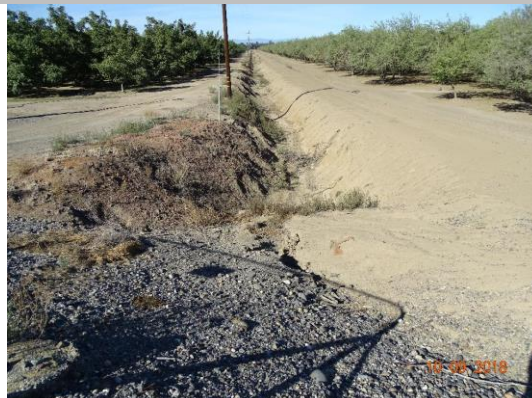
Photo 3 of 3 : UCIP_FA_2019_53340_78136.jpg

Drainage channel on LS.

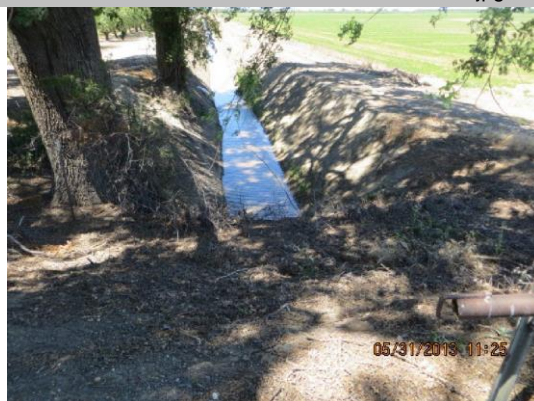
Photo 1 of 3 : UCIP_FA_2019_14565_24009.jpg

Comment Code					
Inspector Comment					
DS_ID:22925 FS_ID:14565 EP_NO: 9556 Repair Type: No Action Needed Crossing Status: Found UCIP Comments: FIELD_STRUCT_DESC: 48-inch corrugated metal drainage pipe through the levee, 11 feet below the crown. Flap gate on the waterside (WS) end. Concrete headwall on both ends. Slide gate in 60-inch diameter corrugated metal riser unit on the WS slope (48-inch pipe [HLM 11.17] authorized under Automatic Board Order (ABO) issued as Permit No. 9556, 1974 - Earl R. and Merrit R. Cooper). [Additional Reference(s): DWR Levee Log, 1992. USACE Sacramento O&M Manual 140, May 1960, (HLM 11.17)]. FS Date: 5/31/2013

Drainage ditch on LS toe.

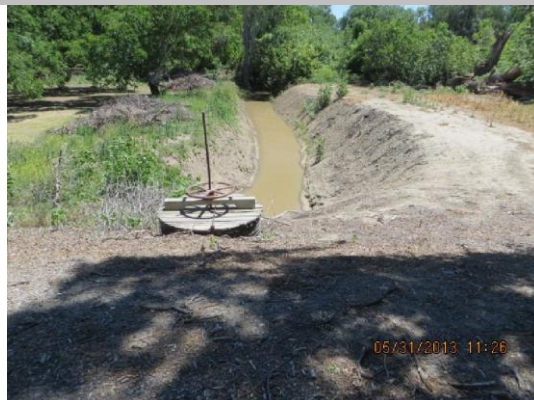
Photo 2 of 3 : UCIP_FA_2019_14565_24008.jpg

Slide gate in 60-inch CMP riser on WS slope.

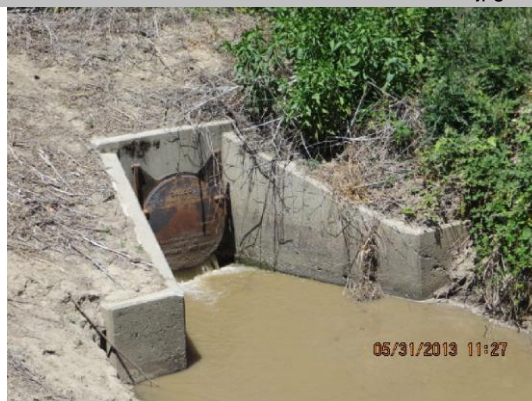
Photo 3 of 3 : UCIP_FA_2019_14565_24007.jpg

Flap gate and concrete headwall on WS toe.

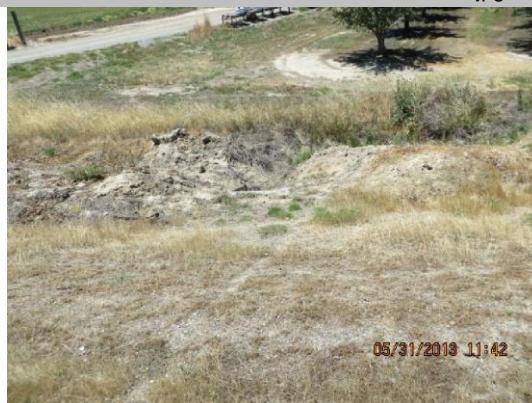
Photo 1 of 3 : UCIP_FA_2019_14566_24013.jpg

LM Start	11.64	Rating **	A/W	Issue No.	420
LM End	11.64	Issue Type +	Ma	Location *	
Category	Supplemental			GPS Latitude/Longitude	
				Start	End
Item	DRAFT DWR UCIP LMA Responsibility			39.623874 °	39.623874 °
				-121.999813 °	-121.999813 °
DWR ID	22926				
Comment Code					
Inspector Comment					
DS_ID:22926 FS_ID:14566 EP_NO: 9555 Repair Type: No Action Needed Crossing Status: Found UCIP Comments: FIELD_STRUCT_DESC: 24-inch corrugated metal drainage pipe through the levee, 8.5 feet below the crown. Flap gate on the waterside (WS) slope. Concrete U-shaped headwalls on both ends. Two corrugated metal cutoff walls. (24-inch pipe [HLM 11.81] authorized under Automatic Board Order (ABO) issued as Permit No. 9555, 1974 - F. S. Reager). [Additional Reference(s): DWR Levee Log, 1992. USACE Sacramento O&M Manual 140, May 1960, (HLM 11.81)]. FS Date: 5/31/2013

Concrete headwall on LS toe.

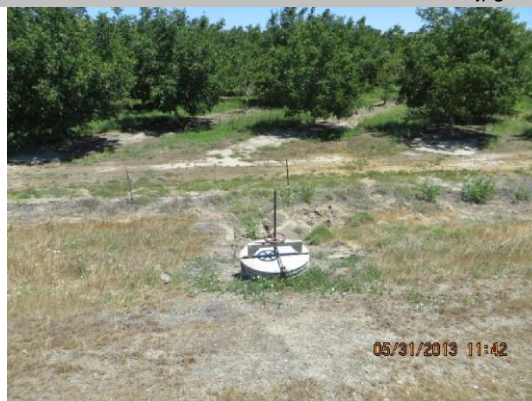
Photo 2 of 3 : UCIP_FA_2019_14566_24012.jpg

Slide gate in 36-inch CMP riser on WS slope.

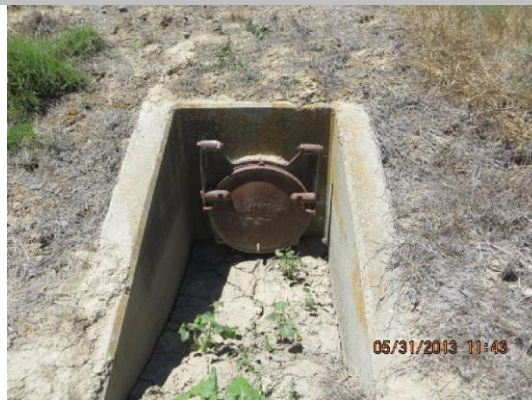
Photo 3 of 3 : UCIP_FA_2019_14566_24011.jpg

Concrete headwall and flapgate on WS toe

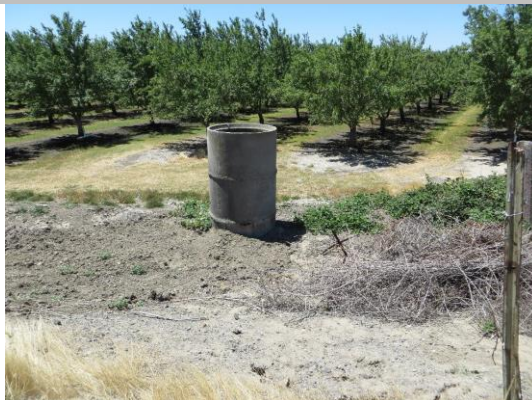
Photo 1 of 3 : UCIP_FA_2019_14567_24017.jpg

Comment Code					
Inspector Comment					
DS_ID:22927					
FS_ID:14567					
EP_NO: 9554					
Repair Type: Non-Urgent					
Crossing Status: Found					
UCIP Comments: Erosion and sloughing on LS slope possibly due to rodent activity in area.					
FIELD_STRUCT_DESC: 24-inch corrugated metal drainage pipe through the levee, 11 feet below the crown. Slide gate in 36-inch corrugated metal riser unit on the waterside (WS) slope. 48-inch concrete standpipe on the landside (LS) toe. Two corrugated metal cutoff walls. (24-inch pipe [HLM 11.93] authorized under Automatic Board Order (ABO) issued as Permit No. 9554, 1974 - Thomas H. Reed). [Additional Reference(s): DWR Levee Log, 1992. USACE Sacramento O&M Manual 140, May 1960, (HLM 11.93)].					
FS Date: 5/31/2013

Concrete standpipe on LS toe.

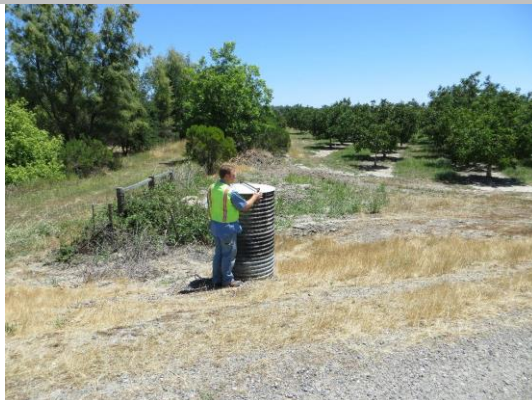
Photo 2 of 3 : UCIP_FA_2019_14567_24016.jpg

Slide gate in CMP riser on WS toe.

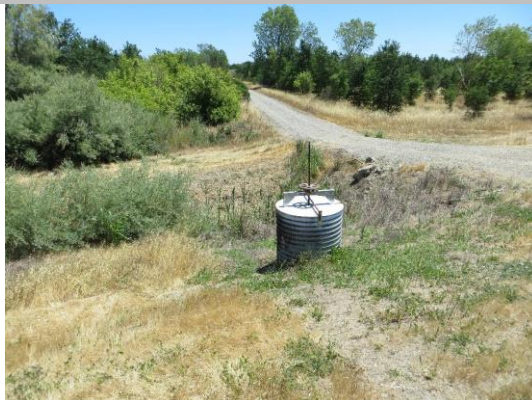
Photo 1 of 3 : UCIP_FA_2019_14569_24026.jpg

Comment Code					
Inspector Comment					
DS_ID:22928					
FS_ID:14569					
EP_NO: 9554					
Repair Type: Non-Urgent					
Crossing Status: Found					
UCIP Comments: Flap gate heavily corroded. Good candidate for video inspection. Vegetation interfering with inlet.					
FIELD_STRUCT_DESC: 24-inch corrugated metal drainage pipe through the levee, 7 feet below the crown. Flap gate on the waterside (WS) end. Slide gate in 36-inch corrugated metal pipe riser unit on the WS slope. Concrete headwalls on both ends. Two corrugated metal cutoff walls. (24-inch pipe [12.04] authorized under Automatic Board Order (ABO) issued as Permit No. 9554, 1974 - Thomas H. Reed). [Additional Reference(s): DWR Levee Log, 1992. USACE Sacramento O&M Manual 140, May 1960, (HLM 12.04)].					
FS Date: 5/31/2013

Slidegate in 36-inch CMP riser on WS slope.

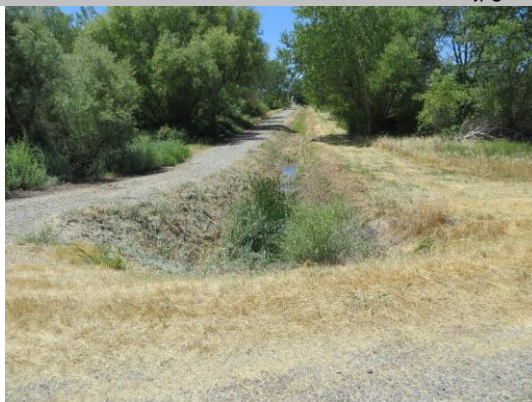
Photo 2 of 3 : UCIP_FA_2019_14569_24025.jpg

Drainage channel on LS toe.

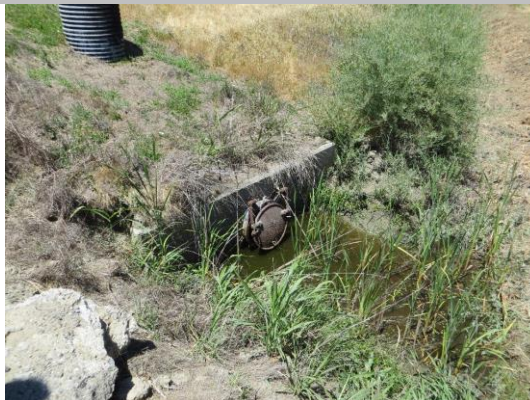
Photo 3 of 3 : UCIP_FA_2019_14569_24024.jpg

Headwall and flapgate on WS toe.

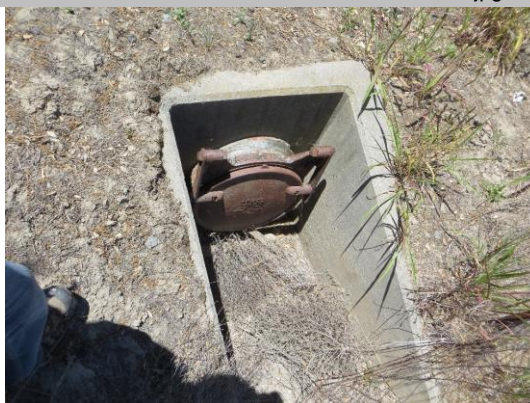
Photo 1 of 3 : UCIP_FA_2019_14570_24029.jpg

Comment Code						
Inspector Comment						
DS_ID:22929 FS_ID:14570 EP_NO: 9554 Repair Type: No Action Needed Crossing Status: Found UCIP Comments: FIELD_STRUCT_DESC: 24-inch corrugated metal drainage pipe through the levee, 7 feet below the crown. Flap gate on the waterside (WS) end. Slide gate in 36-inch corrugated metal riser unit on the WS slope. Concrete U-shaped headwalls on both ends. (24-inch pipe [HLM 12.29] authorized under Automatic Board Order (ABO) issued as Permit No. 9554, 1974 - Thomas H. Reed). [Additional Reference(s): DWR Levee Log, 1992. USACE Sacramento O&M Manual 140, May 1960, (HLM 12.29)]. FS Date: 5/31/2013

Flapgate and U-shaped concrete headwall on WS toe.

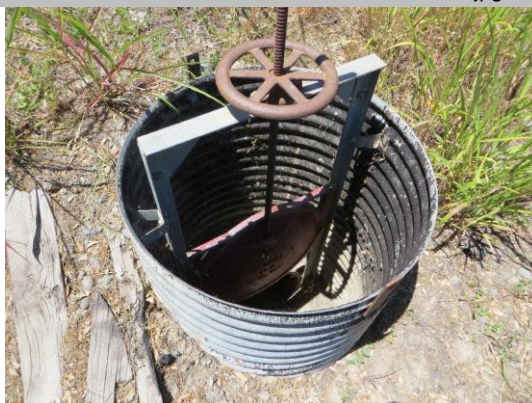
Photo 2 of 3 : UCIP_FA_2019_14570_24028.jpg

Item	DRAFT DWR UCIP LMA Responsibility			39.630451 °	39.630451 °	
				-122.002737 °	-122.002737 °	
DWR ID	22929					
Comment Code						
Inspector Comment						
DS_ID:22929 FS_ID:14570 EP_NO: 9554 Repair Type: No Action Needed Crossing Status: Found UCIP Comments: FIELD_STRUCT_DESC: 24-inch corrugated metal drainage pipe through the levee, 7 feet below the crown. Flap gate on the waterside (WS) end. Slide gate in 36-inch corrugated metal riser unit on the WS slope. Concrete U-shaped headwalls on both ends. (24-inch pipe [HLM 12.29] authorized under Automatic Board Order (ABO) issued as Permit No. 9554, 1974 - Thomas H. Reed). [Additional Reference(s): DWR Levee Log, 1992. USACE Sacramento O&M Manual 140, May 1960, (HLM 12.29)]. FS Date: 5/31/2013

Slidegate in 36-inch CMP riser on WS slope.

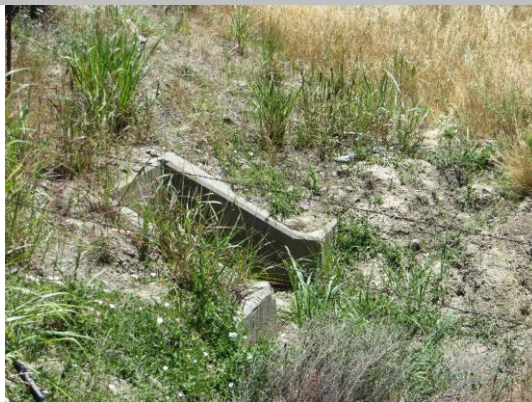
Photo 3 of 3 : UCIP_FA_2019_14570_24027.jpg

U-shaped concrete headwall on LS toe.
